Exmoor National Park
Historic Environment Report Series No 20

DULVERTON CONSERVATION AREA: APPRAISAL DOCUMENT

Consultation Draft: November 2014

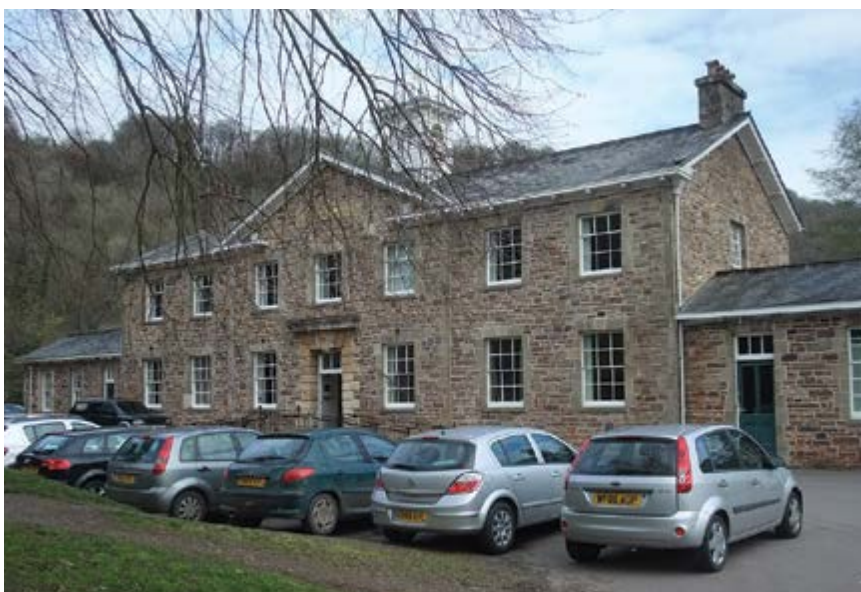
Fig. 43 Exmoor House,
former workhouse now
Exmoor National Park HQ

Close to the river, **Exmoor House** (Fig. 43) is set well back from Bridge Street and apart from the town. It was built as a Union Workhouse in 1855 and converted to council offices in the middle 20th century – a role it still fulfils as the headquarters of the National Park. Two storeys in height, it is built of local stone rubble with dressings around openings. The frontage contains a central block with an open pediment and flanking wings. There are ground floor 12-pane and first floor 9-pane sash windows. Above the deep eaves is a slate roof topped by a central wooden lantern with shallow pyramid roof and arched louvred openings on each face.

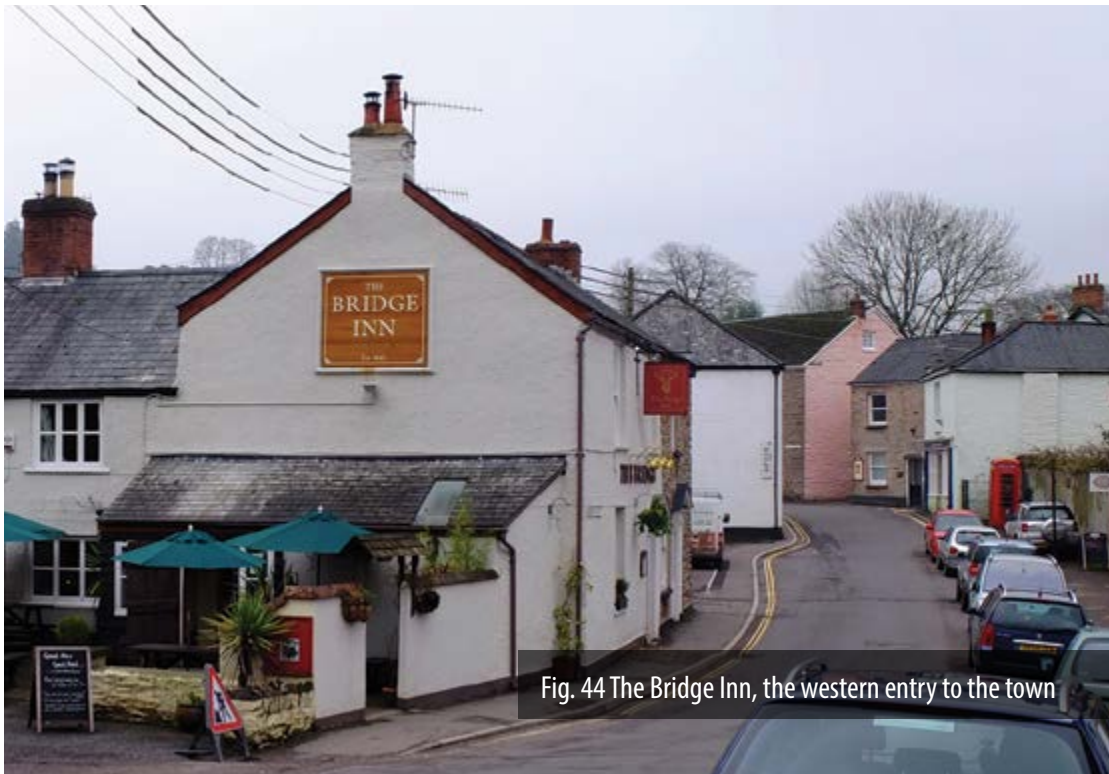
Fig. 44 The Bridge Inn, the western entry to the town

In Bridge Street, **Bridge Inn** and **Bridge Cottage** (Fig. 44) are both early-mid 19th century (the date of 1845 is marked out in pavement cobbles at the front). Built of stone rubble, the former occupies a prominent corner plot. Both have broken pedimented door-cases on the Bridge Street frontage, one with a round-headed arch, the other elliptical arch, both have fanlights with radial bars.

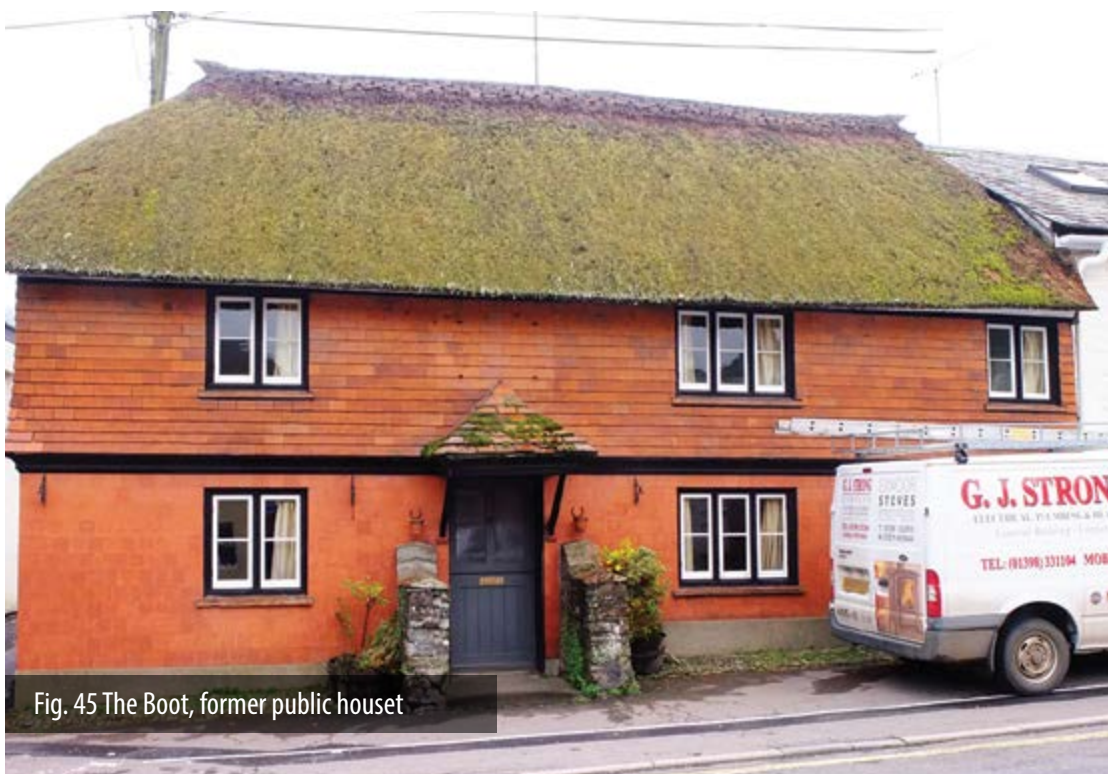
Set slightly back from the street, **The Boot** (Fig. 45) has a late-19th century tile hung and quarry tile frontage added to an earlier, possibly three-cell and cross-passage 17th century cottage, and is still thatched. The casement windows with single horizontal glazing bar probably date from the 19th century updating.

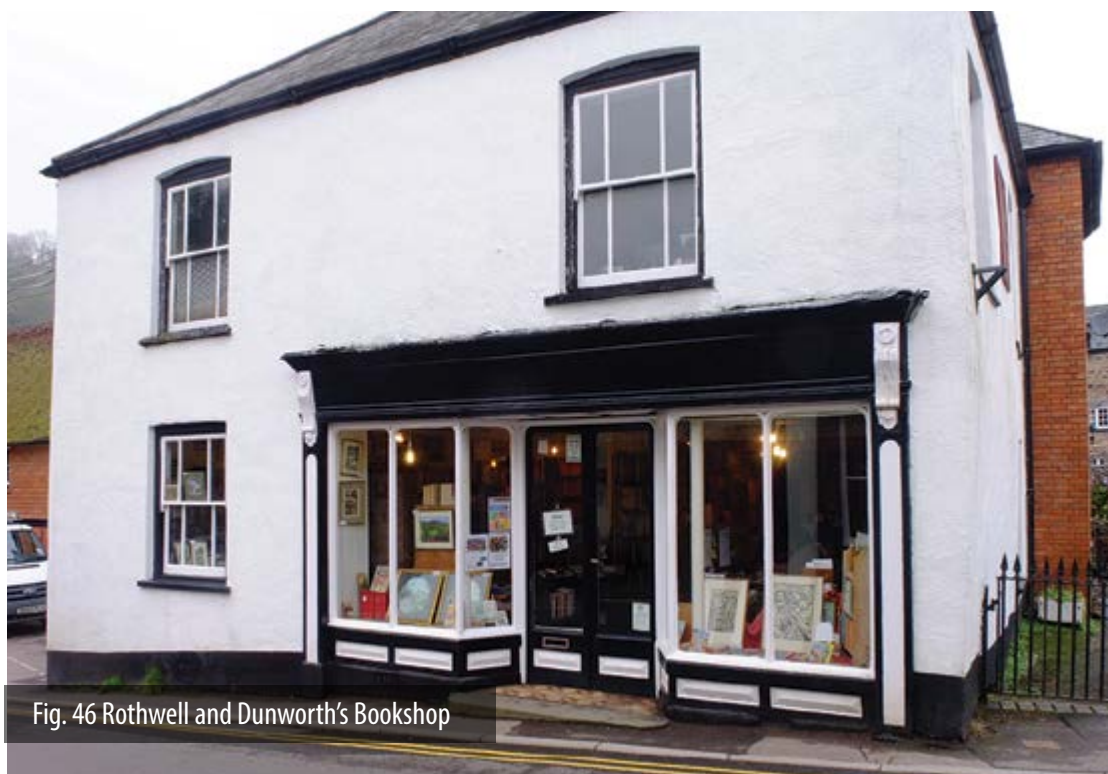
Fig. 46 Rothwell and Dunworth's Bookshop

In contrast, **Rothwell and Dunworth's Bookshop** (Fig. 46) stands forward of the building line. It has a good late 19th century shop-front with carved console brackets, moulded mullions and lozenge panels to the stall riser. There is a brick built rear wing, probably later in date running alongside the leat with four round-headed windows, which suggests some former commercial or industrial use.

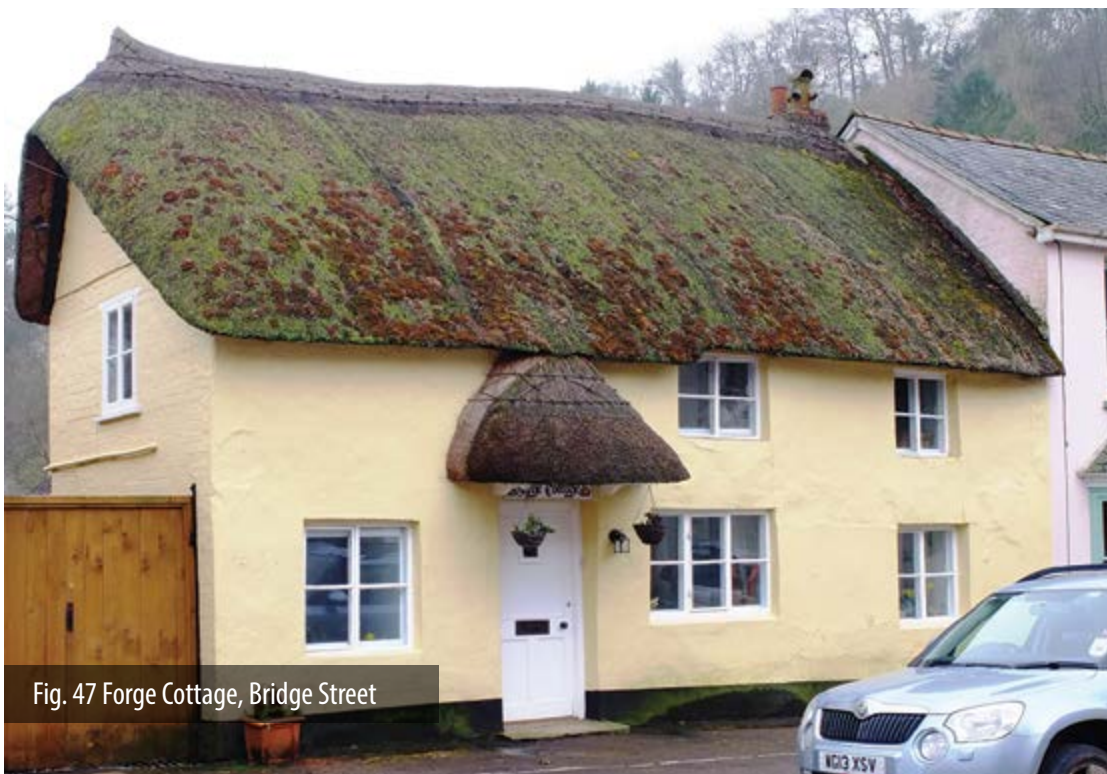
Fig. 47 Forge Cottage, Bridge Street

On the opposite side of the road is **Forge Cottage** (Fig. 47) thatched and possibly 18th century with later 19th century casement windows. It is predominantly rendered presumably over rubble - the gable end is a brick extension. The thatched porch which reaches almost to the eaves is also an addition. Next door, **Farthings** (Fig. 48) is a mid-late 19th century fronted house with possible earlier origins. The three-bay frontage with ground floor canted bays, has sash windows with vertical bars, and a panelled entrance door with plain fanlight above.

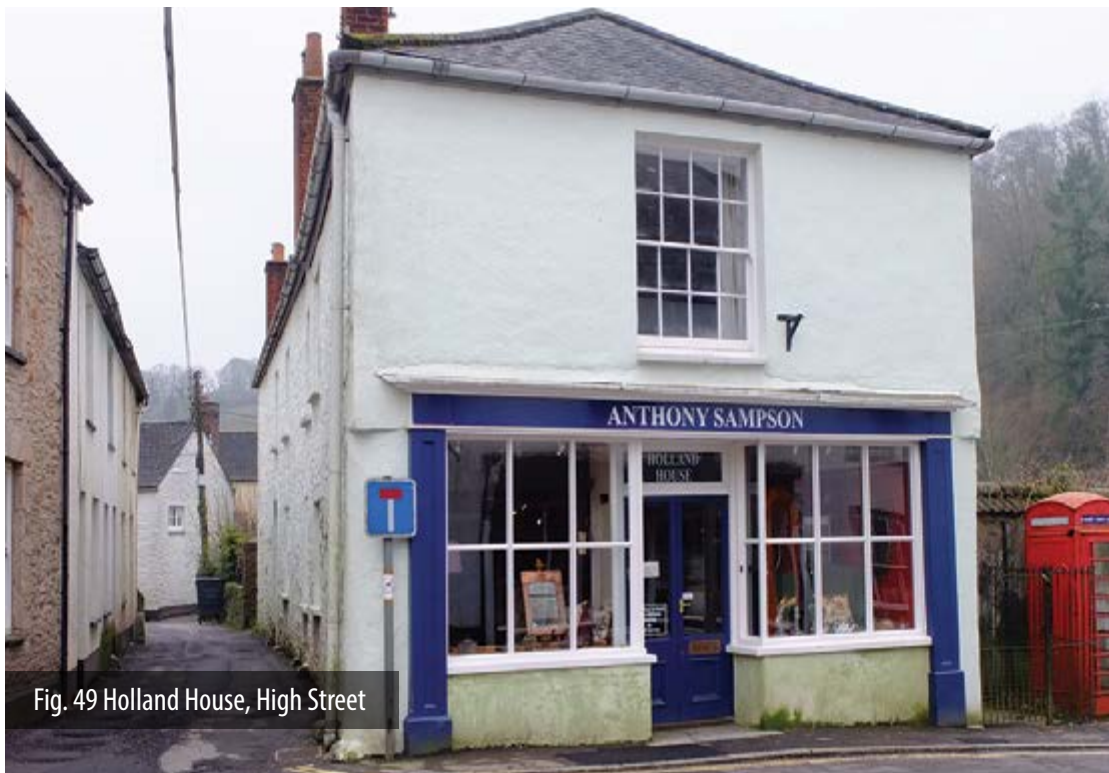
Fig. 49 Holland House, High Street

At the corner of **Chapel Street** and **High Street** is **No. 4** and **Holland House** (Fig. 49) both are probably early 19th century. Fronting Bridge Street, Holland House has a double shop-front with 20th century half-glazed double door with 16-pane sash window above. To the rear, No. 4 has a four-bay frontage with first floor 16-pane sash windows, and a plank door under a porch set in the angle with the adjoining Old Bakehouse, which is probably early 19th century and occupies a recessed position behind a wall and railings.

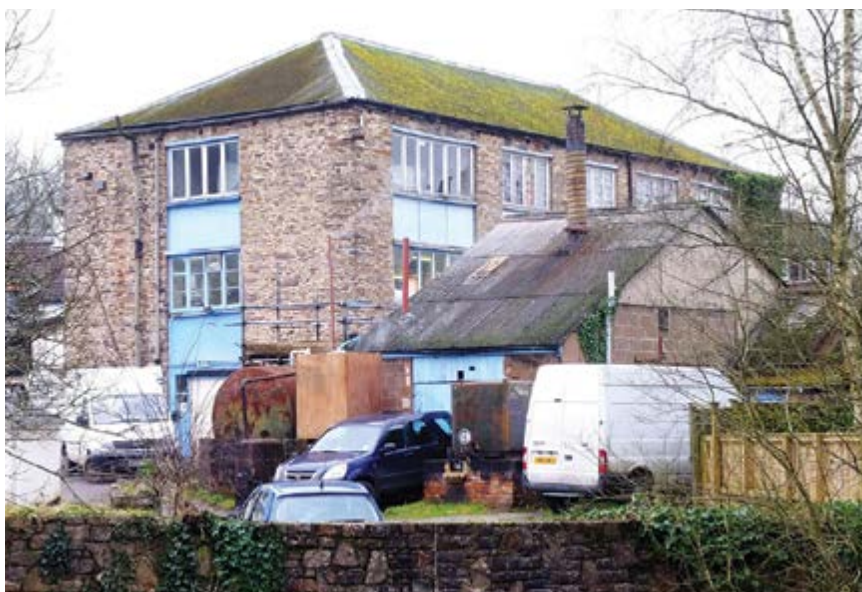
Fig. 50 Dulverton Laundry, a former mill.

Further down Chapel Street is **Dulverton Laundry** (Fig. 50). Originally water driven, this was formerly a crepe mill, and is a good example of an early industrial building. Pevsner describes it as 'a fine, rational early 19th century design'. It is three-storeys, built of local stone rubble with recessed bays and some wooden panels between windows. There are six-light windows and some multi-paned leaded-light casements on the second floor.

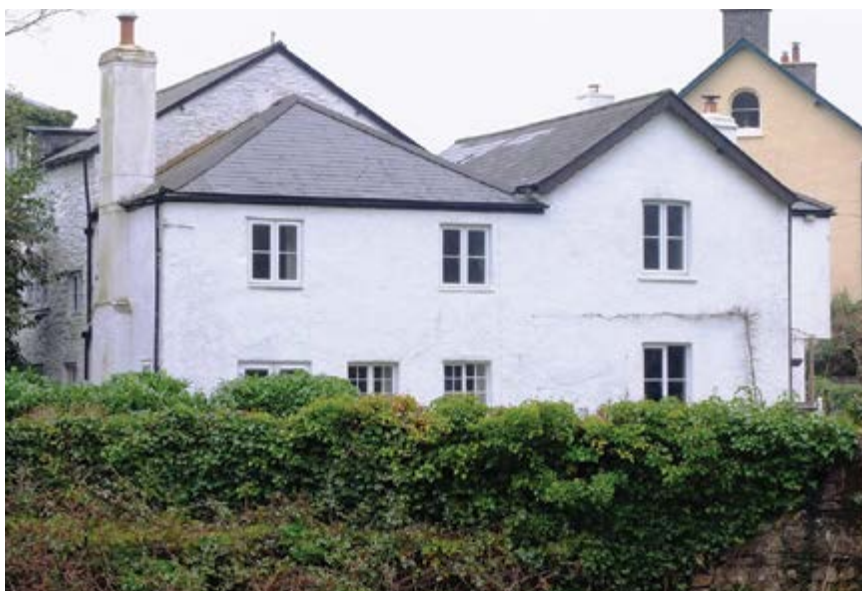
Fig. 51 Lower Mill – now private house

Immediately south, **Lower Mill** (Fig. 51) appears to be of three builds with a three storey rubblestone building and late-19th century rendered extension with hipped and gabled slate roofs to the south.

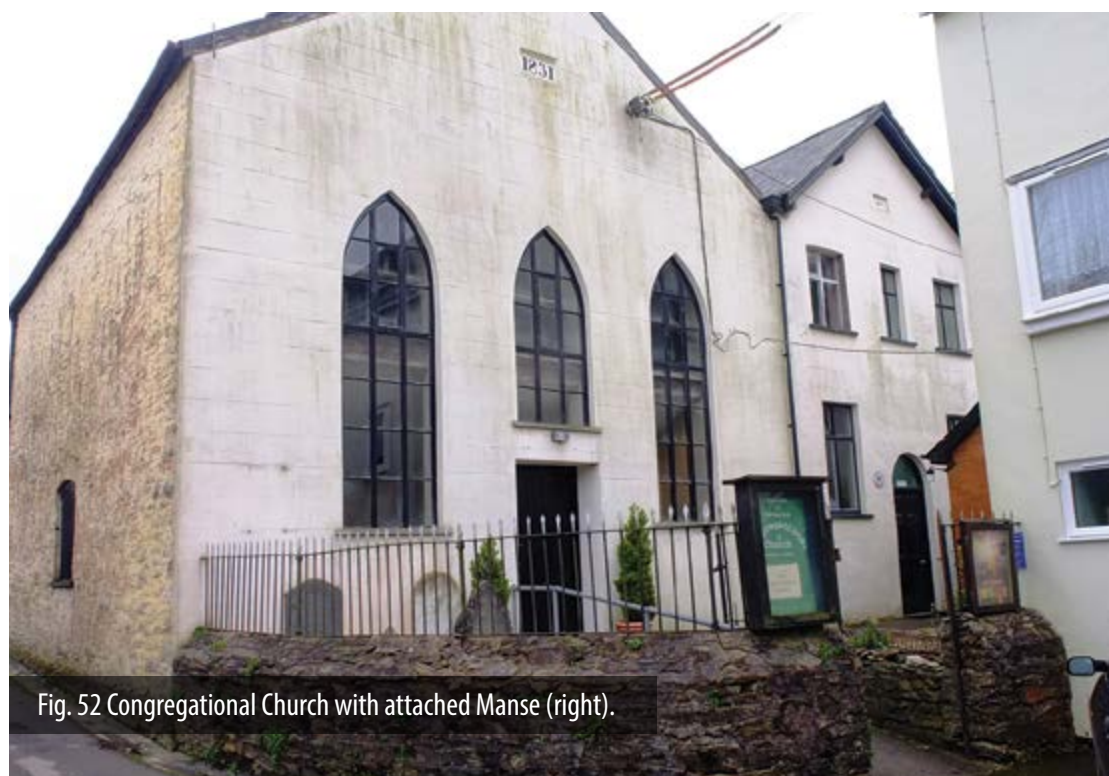
Fig. 52 Congregational Church with attached Manse (right).

Back on Chapel Street, the **Congregational Church** (Fig. 52) dates from 1831 and has a rendered frontage, lined as ashlar. Its three pointed-arch windows have divided tracery, and it has a slate-hung rear elevation. The attached Manse was added in 1877 and is rendered under a slate roof.

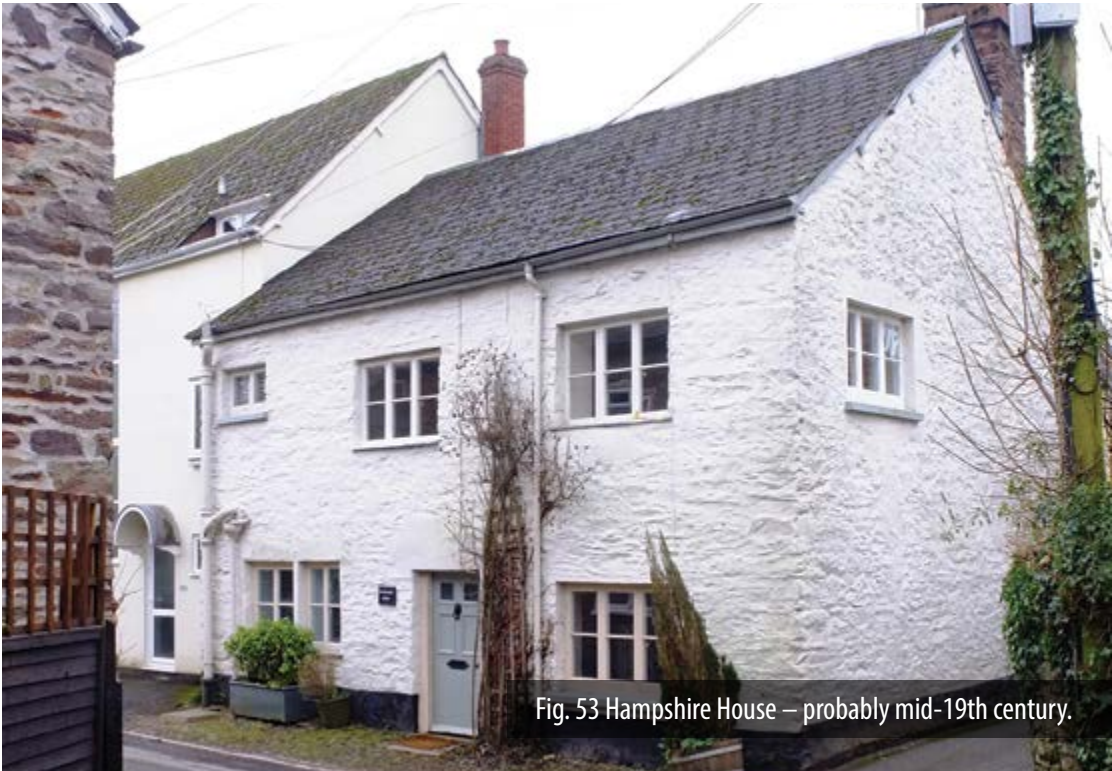
Chapel Street has a number of cottages, mainly dating to the mid-19th century. **Hampshire House** (Fig. 53), is representative of these with a painted stone rubble frontage and cobbled forecourt. The six-panel entrance door has two fixed lights and the timber casement windows each have a single horizontal glazing bar. Nos. 11-13 opposite have a modern plaque with a date of 1660. Others retain good detailing, such as the rustic porches at **Myrtle Cottage** (Fig. 76) and **Poolston Cottage**.

Fig. 53 Hampshire House – probably mid-19th century.

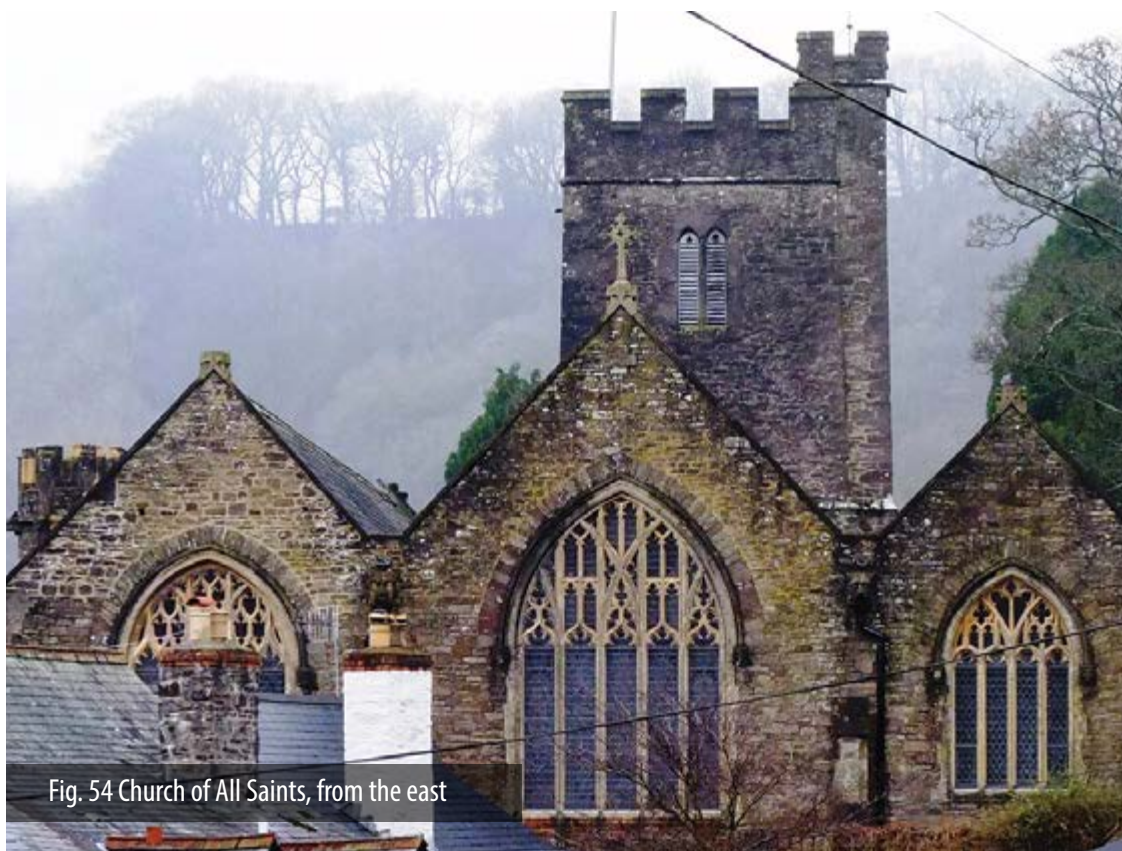
Fig. 54 Church of All Saints, from the east

The **Parish Church of All Saints** (Fig. 54) is set further up the slope and is accessed from the town centre to the south through a gothic style **lych gate** (Fig. 55) dating to 1907 with decorative clay-tile roof and ornate pierced bargeboards. Although originally medieval, the Church was largely rebuilt in 1853-5 and in its current guise is mainly 19th century although it retains some earlier features of interest internally. The three stage tower, which is possibly 13th century, was also restored at this time

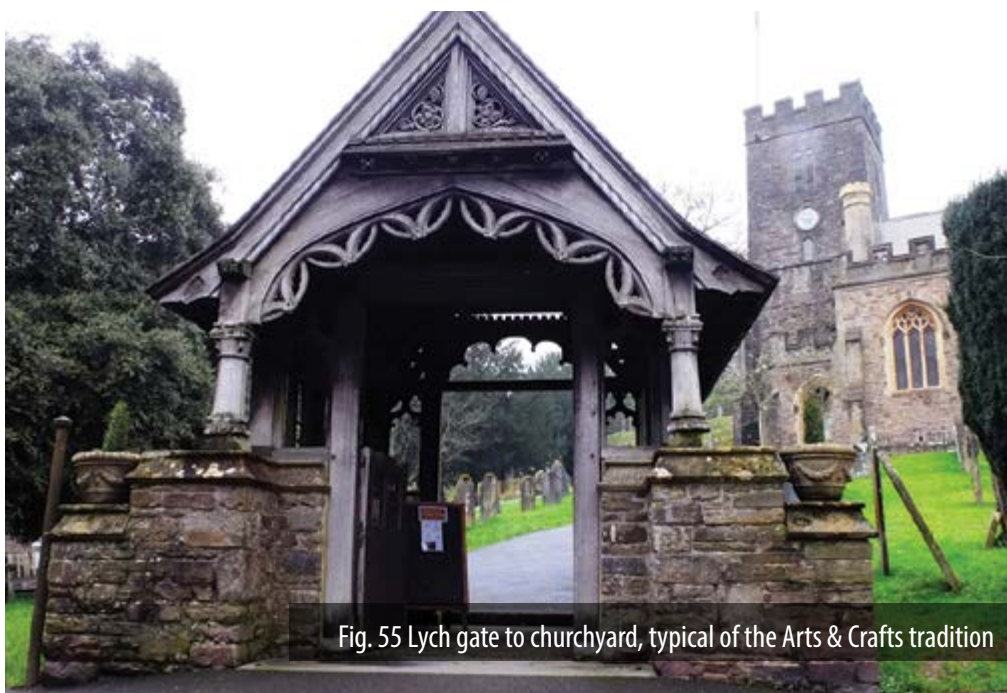
Fig. 55 Lych gate to churchyard, typical of the Arts & Crafts tradition

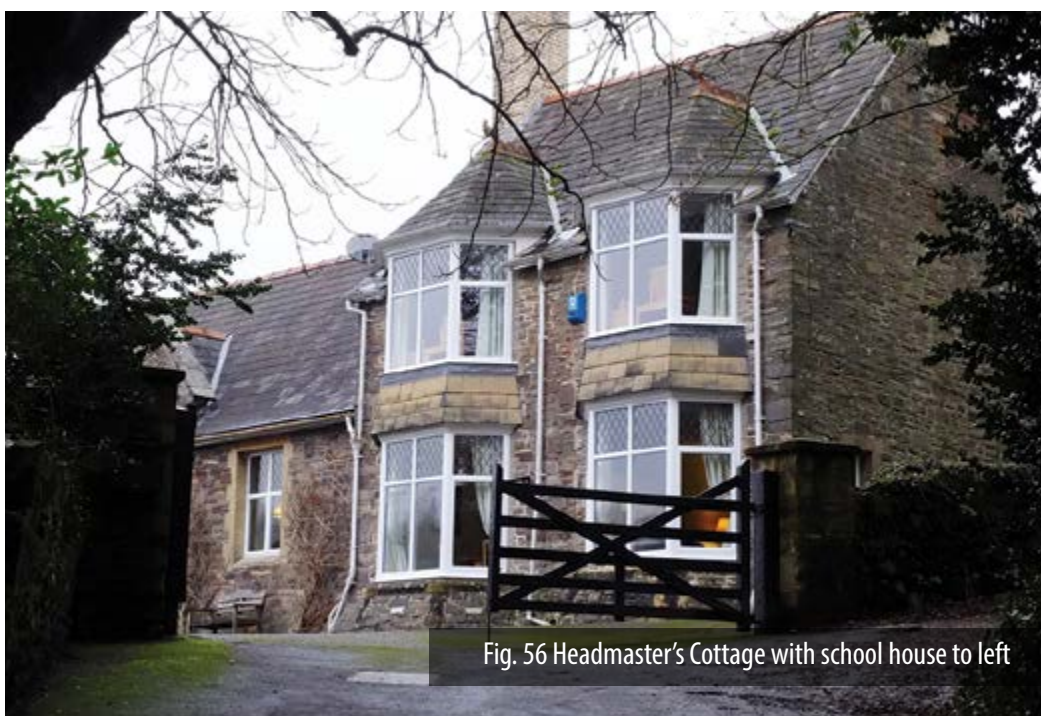
Fig. 56 Headmaster's Cottage with school house to left

Set above and behind the Church is the **Old School House** and **Headmaster's Cottage** (Fig. 56). As the name suggests, this is the site of the former Primary School, built in typically late-19th century style of stone rubble with steeply pitched slate roof and imported dressed stone for openings, some with pointed arches.

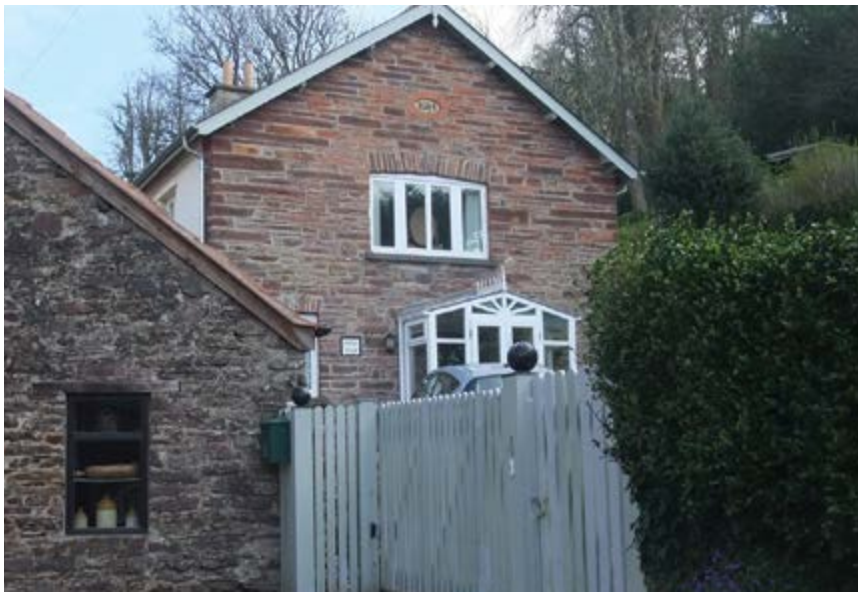
Fig. 57 Former Plymouth Brethren Chapel, now dwelling.

From the former school the lane curves sharply downhill to Town Marsh where there is a small group of mainly 19th century buildings, which include **Marsh Hall** (Fig. 57) a former Plymouth Brethren Chapel built in 1884 by the Mildmay family and now a private house. Adjoining is a single storey building with timber shutters, which is shown as a **Smithy** (Fig. 58) on early Ordnance Survey map. The remains of a water-wheel demonstrates that it was formerly powered by the stream running down the valley known as Marsh Water.

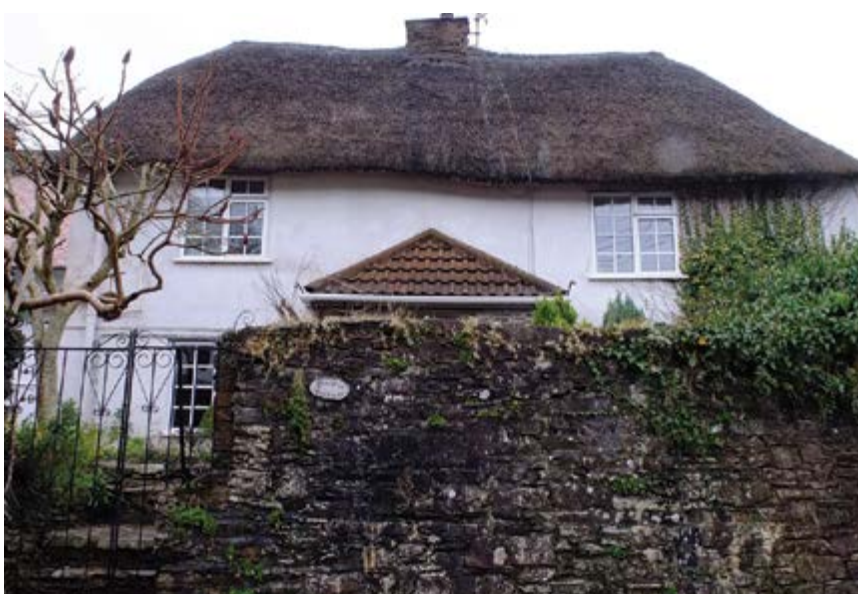
Fig. 59 Wisteria Cottage

At the town end of School Lane is **Wisteria Cottage** (Fig. 59), rendered with a thatched roof and central brick chimney stack – probably dating to the 18th century. On Hollam Lane behind is **Rock Cottage**, probably early-19th century and fronting Jury Road, **Rock House Inn** (Fig. 60), which has original 19th century frontage detail with panelled entrance door with plain overlight. The sash windows have vertical glazing bars and narrower margin panes - a common Dulverton pattern. Opposite is **Woodcote** (Fig. 61), a long and tall late-19th century building extended in the early 20th century with some Arts & Crafts features, including an ornate studded door fronting the road with chevron panels and original metal door furniture.

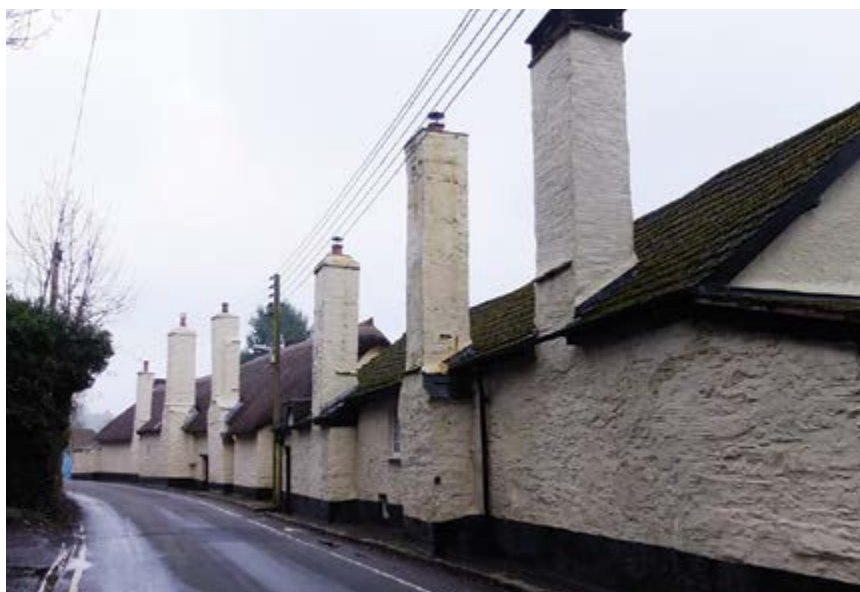
In Jury Road, on the eastern approach to Dulverton, are two buildings of high historic interest. **Woodliving (formerly Wood Tenement)** (Fig. 62), is a former farmhouse dating from the 16th century, but extended in the 17th and early-19th century. The listing description refers to much early timber and other interior features, including four pairs of jointed cruck trusses, peaked and round-headed doorframes, plank and muntin screen, timber-framed partitions with late-16th –early-17th century painted panels, and a 16th century grate. Adjoining is **Woodlands** (Fig. 62), a former three-cell and cross-passage farmhouse, probably 16th century, but extensively altered in the mid-19th century and mid-late-20th century. The tall stacks rising from the eaves of the outshot complement those of its neighbour. The formerly thatched roof, however, now sports concrete tiles.

Fig. 62 Woodliving (left) and Woodlands (right) – the six large stacks are a local landmark

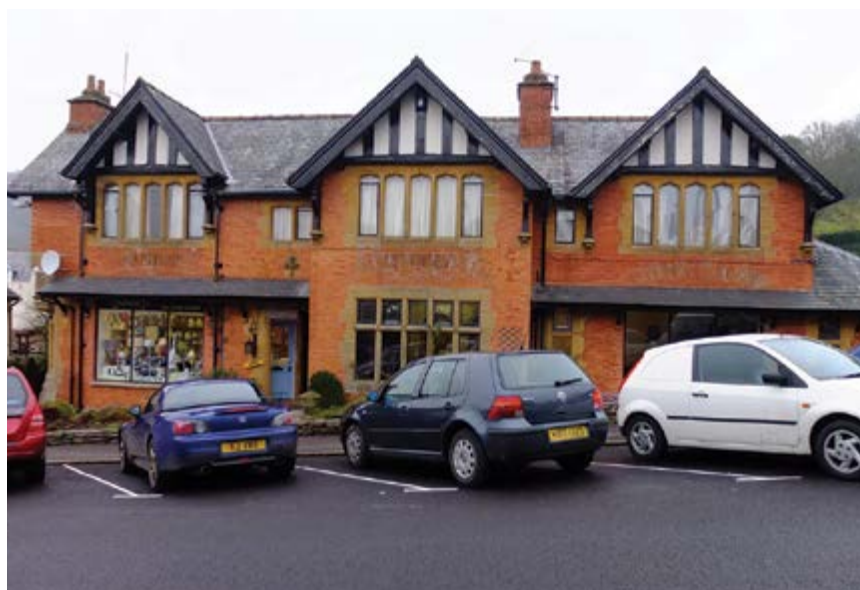
Back on Vicarage Hill, the north side is dominated by the half-timbered three gabled frontage of **Wreneaton House** (Fig. 63), a distinctive Arts & Crafts style building dating to c.1900. The orangey-red colour Wellington bricks with Ham stone dressings give the building an incongruous presence in the streetscape but it has high quality detailing, best seen in the Scottish baronial style corner detail with an ogee headed window and canopy with niche above (Fig. 64). There are also dressed stone entrances and mullioned windows, some with leaded light glazing and ogee moulding. Opposite, **The Vicarage** is an imposing late Victorian house set in own grounds – much altered, it may have earlier origins.

Fig. 63 Wreneaton House – a fine Arts and Crafts building.

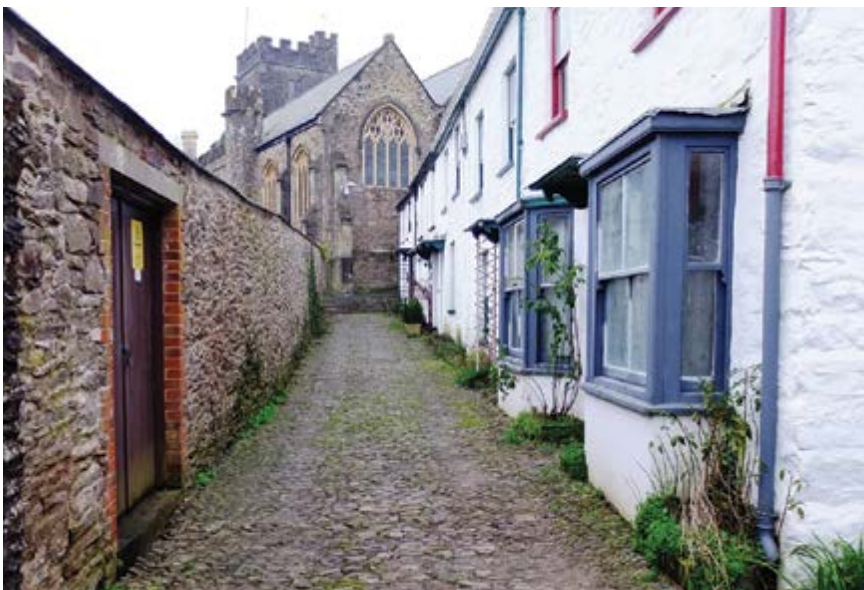
Leading to the Church, **1-5 Church Lane** (Fig. 65) is a terrace of five houses. These are unlikely to have been built at the same time and the two closest to the church, Nos 1 and 2, could possibly be 150 years earlier than their neighbours. The painted stone rubble frontages are complemented by the entirely cobbled surface of the street contained by a stone wall and with the parish church closing the view. Each cottage has a straight hood porch on brackets over the entrance door, which is panelled and has a rectangular overhead light. No.1 has late-19th century bay windows on the ground floor.

Fig. 65 1-5 Church Lane, 19th terrace with possible earlier origins.

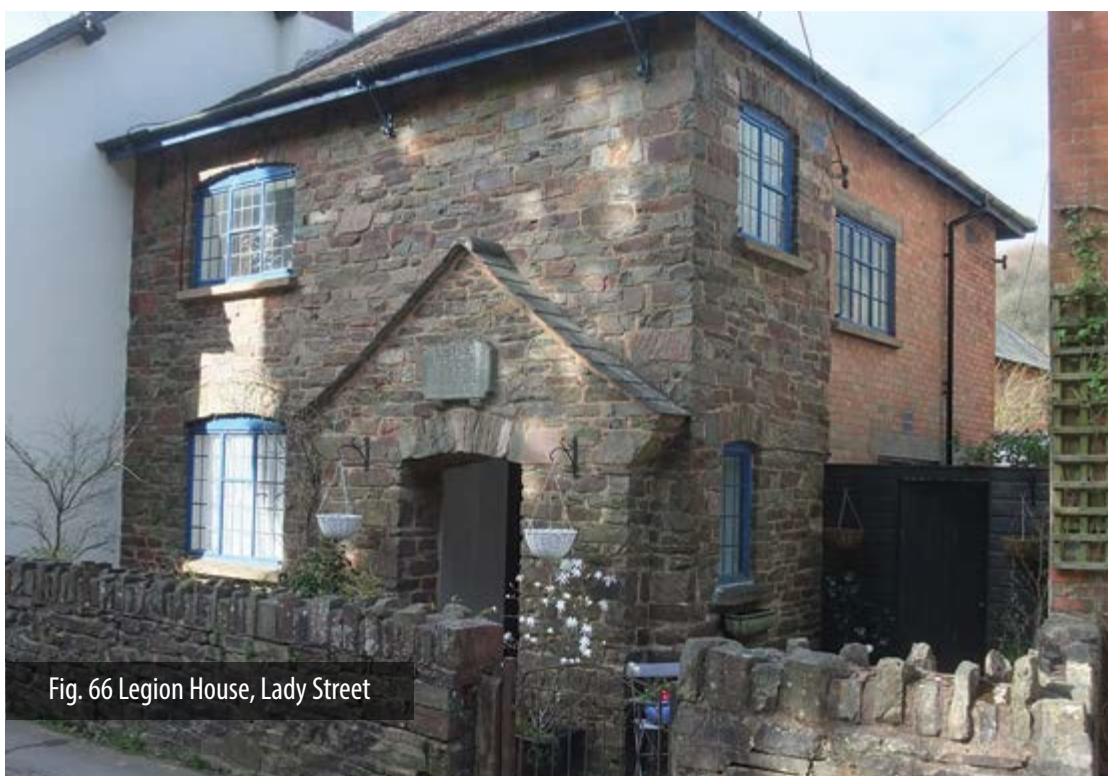
Fig. 66 Legion House, Lady Street

Now mainly domestic in character there are a number of buildings which formerly had other uses. **Legion House** (Fig. 66) is an interesting late example of an Arts & Crafts style stone built frontage (dated 1954 on the stone plaque), including a large porch and oak plank stable door with forged strap hinges, all rather incongruously attached to the brick built rear.

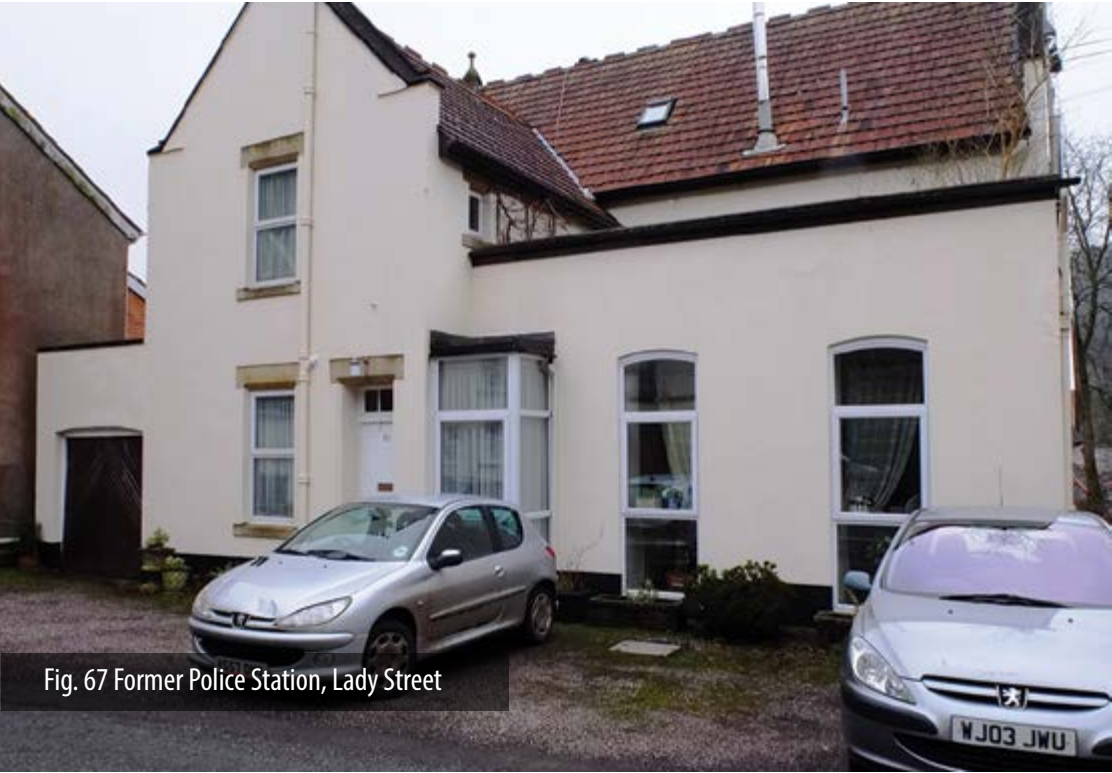
Fig. 67 Former Police Station, Lady Street

Externally, there is little to disclose **No. 20's** former life as the Police Station (Fig. 67), although the chamfered stone window and door lintels are still visible. Similar in date but easier to identify is the **former Bible Christian Chapel** (Fig. 68) of 1902, built of red and cream brick with stone detailing. The adjoining semi-detached pair of houses, **Nos 24-26 Lady Street**, are similarly constructed with No. 26 retaining its original sash windows.

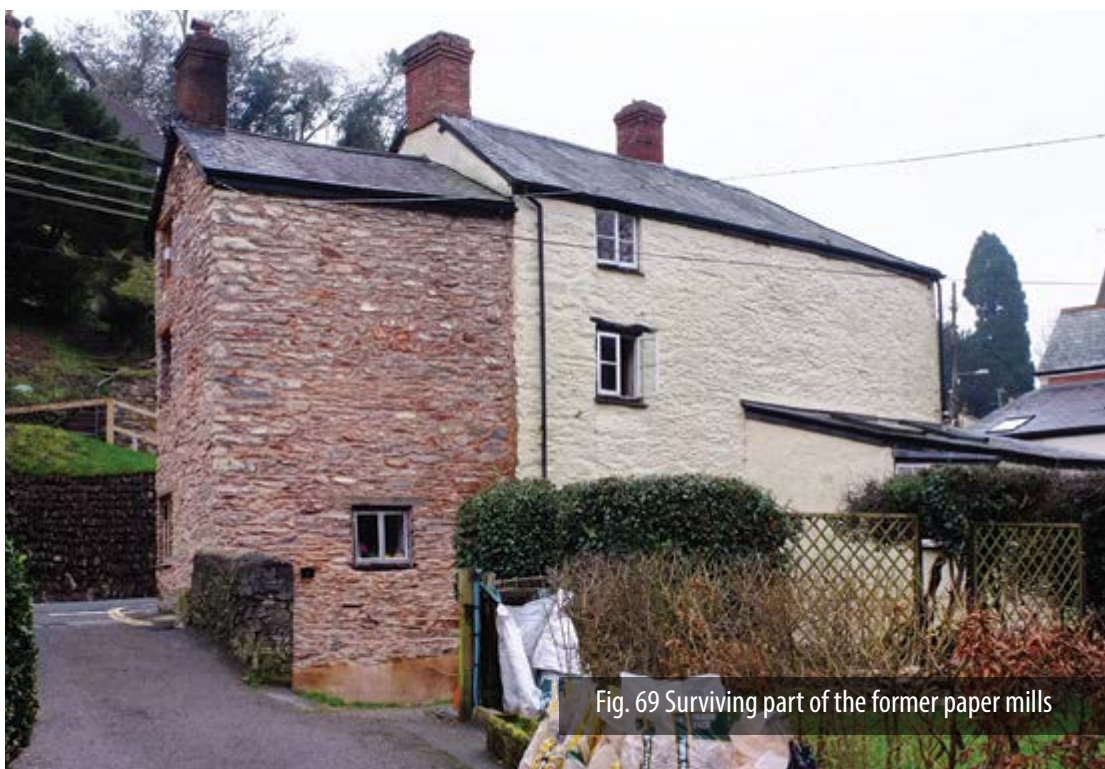
Fig. 69 Surviving part of the former paper mills

Northmoor Road contains mainly later 19th century buildings directly fronting the east side of the street with some later development between the mill leat and the Barle. **No. 32** (Fig. 69) is an earlier building than its neighbours. It is three-storey and built of stone rubble with timber lintels and small casement windows. It probably dates from the 18th century and was part of the former paper mill.

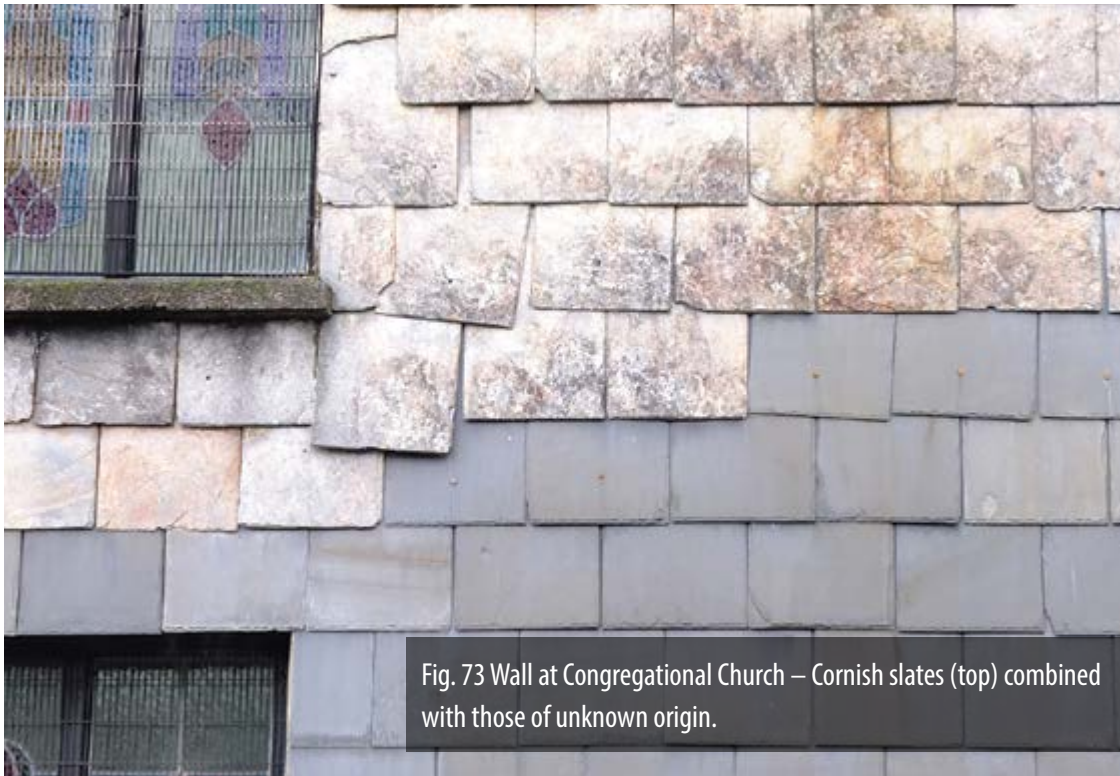
Traditionally, almost all the 19th century and earlier domestic buildings would have been rendered and/or lime washed. In some cases this has since been removed or replaced using cement and plasticised paint. Some of this render may be disguising cob rather than stone. Slate hung walls do occur but are less prevalent in Dulverton than elsewhere on Exmoor, the rear wall of the Congregational Church (Fig. 73) is a rare exception.

Fig. 73 Wall at Congregational Church – Cornish slates (top) combined with those of unknown origin.

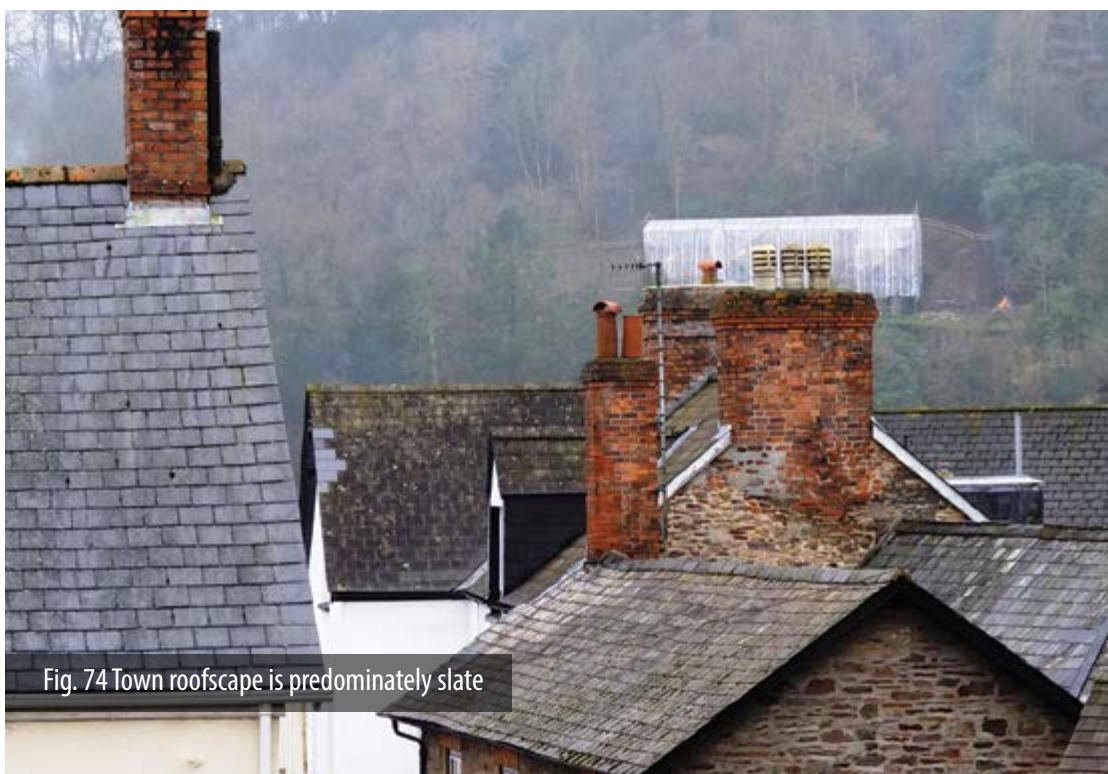
Traditionally thatch would have been a more prevalent form of roofing material, but from the late 18th century slate was more commonly used, especially in towns where there was the ever present risk of fire spreading. Today Welsh slate predominates, but a significant proportion has either been turnerised or has been replaced by varieties of artificial slate. More recently, imported natural slate has appeared. Evidence of local slate, which originated mainly from the Brendon Hills where a few slate quarries flourished until the early 20th century, is scarce in the town. From the late 19th century onwards, the main alternative to slate was the red clay double-Roman tiles, sourced from the Bridgwater area. Plain tiles also began to be used on new buildings from this time, but are less commonplace.

Fig. 74 Town roofscape is predominately slate

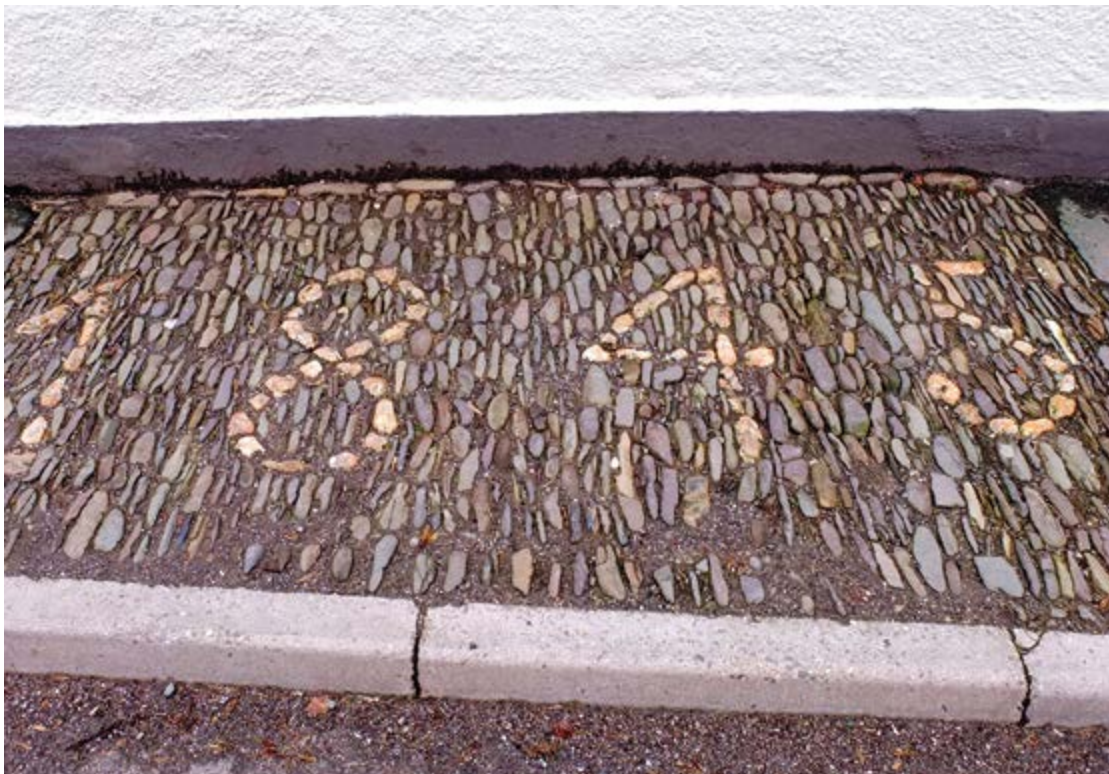
Fig. 80 Decorative cobbles show date outside the Bridge Inn.

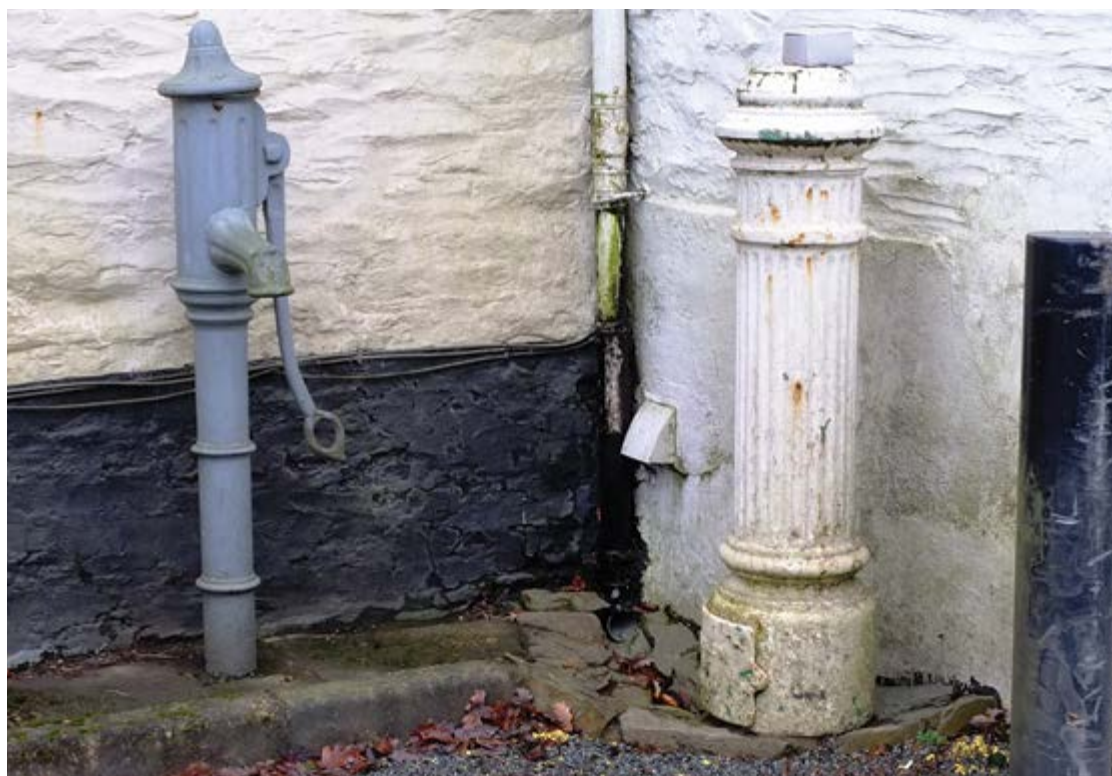
Fig. 81 Bollard and hand pump at Northmoor Road

On Lady Street towards Northmoor is a bollard and hand pump (Fig. 81) dating to the late 19th century: both may have been re-sited. There are also the remains of a hydrant in its own niche at 48 High Street and a more complete example in Church Lane.

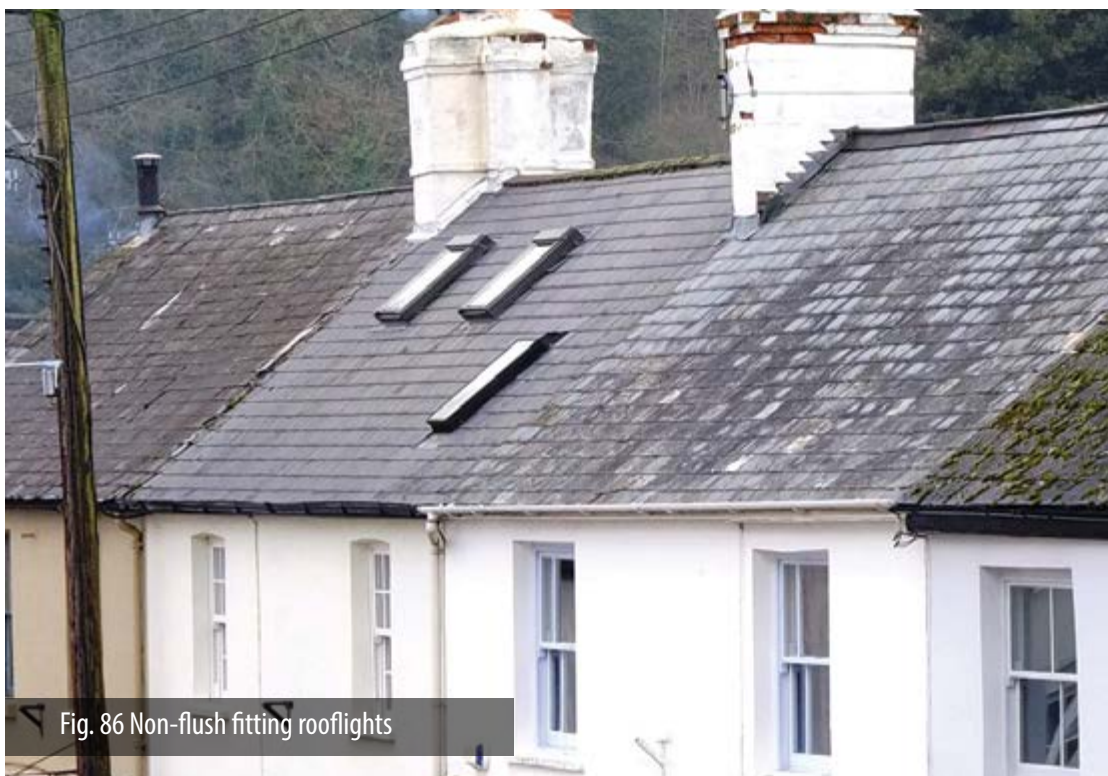
Fig. 86 Non-flush fitting rooflights
